Supporting the Nation's Power Grid through Coatings Management

Proactive Coatings Maintenance Plans Abate Corrosion of Aging Electrical Transmission Structures

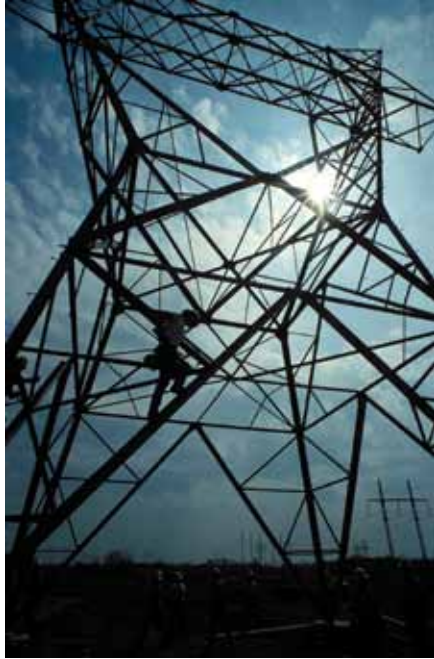
Workers conduct a final inspection of a newly installed galvanized steel transmission tower. Photo courtesy of Alan Holloman, Georgia Power Co.

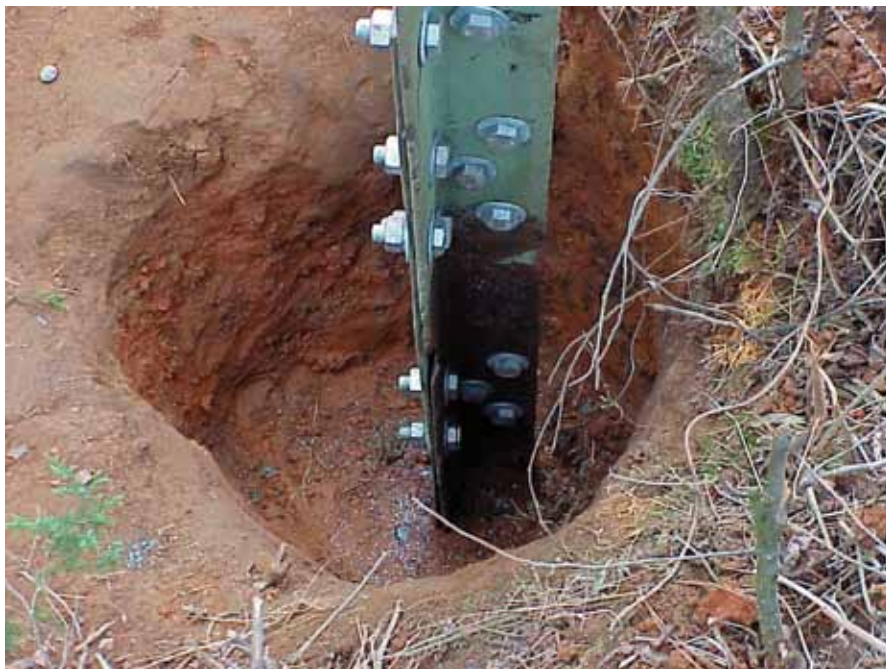
A recently repaired embedded steel footing is shown. Photo courtesy of Alan Holloman, Georgia Power Co.

The ground line inspection, conducted by a specially trained crew, calls for excavating and cleaning embedded steel footings. During a ground line inspection, a structure is rated on a scale of one (like new condition) to five (worst condition) and the data is collected in a hand-held computer. Depending on the rating, the structure is either coated or scheduled for repairs at the transition zone. During the ground line inspection,

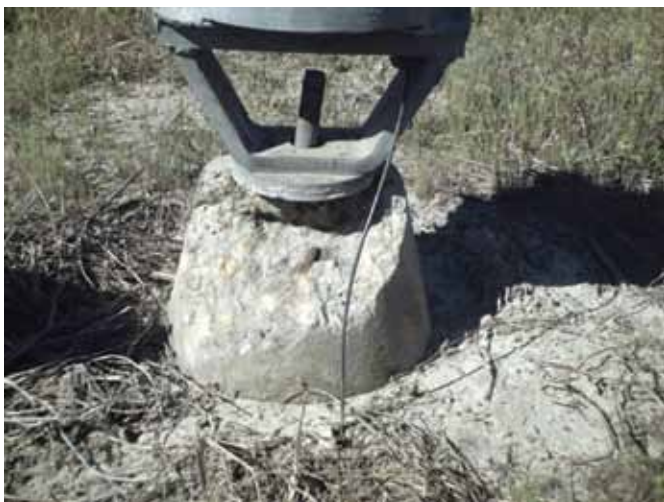
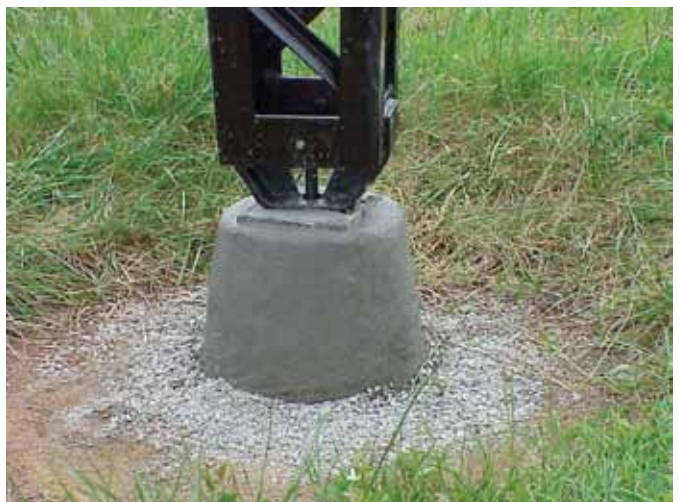
The photos show a broken foundation found during inspection (left) and a repaired foundation with a ground line coating (right). Photo courtesy of Alan Holloman, Georgia Power Co.
